Repair of High Value/High Demand Spiral Bevel Gears by Superfinishing

Eric C. Ames

US Army Research Development and Engineering Command

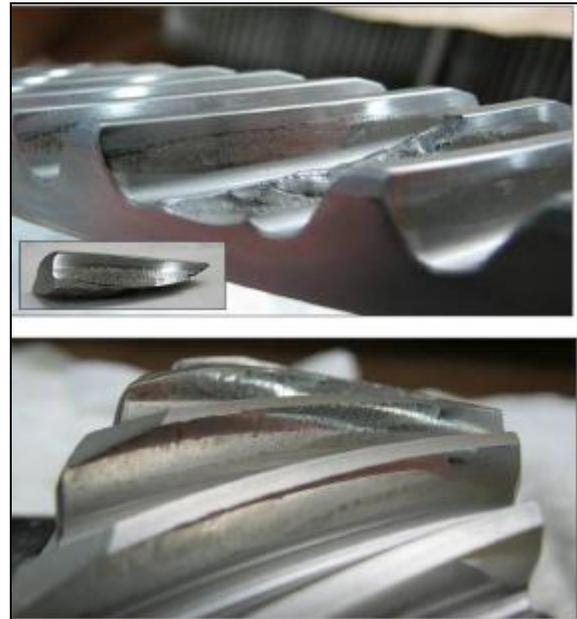
Figure 3. TTO Bevel Gear and Pinion post Block I Overload Testing

The first block of testing was conducted in March of 2010 and utilized a mixture of new production gears and some with very low service usage. Testing revealed that the tail take-off bevel gear mesh has limited tolerance to sustained operation at these high overload conditions. Near the end of the test, a tooth fracture of the tail take-off (TTO) bevel gear was experienced. This fracture likely resulted from a line of micropits that formed on the root of the gear due to high contact pressures from the tip of the mating pinion. Figure 3 shows the posttest condition of both the TTO gear and its

mating gear. Teeth of the TTO bevel gear are all heavily scuffed, and heavy wear, polishing, and scuffing are observed on the TTO pinion teeth.

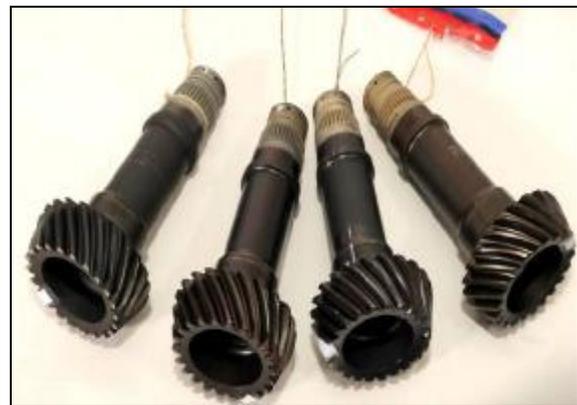
Figure 4. Candidate TTO Pinions as Received from SAFR

The candidate pinions were first sent to Overhaul Support Services (OSS), East Granby CT for nondestructive testing and ranking of the candidates in terms of suitability for repair and reassembly into the test gearbox. OSS is a FAA certified overhaul and repair facility specializing in dynamic components for Sikorsky Aircraft. Each of the pinions was subject to a magnetic particle inspection and found to be free of cracks. OSS ranked the damage of each of the pinions and recommended that two pinions (SN C518-00159 and SN A518-00011) were best suited for repair with SN C518-00159 being the least damaged.

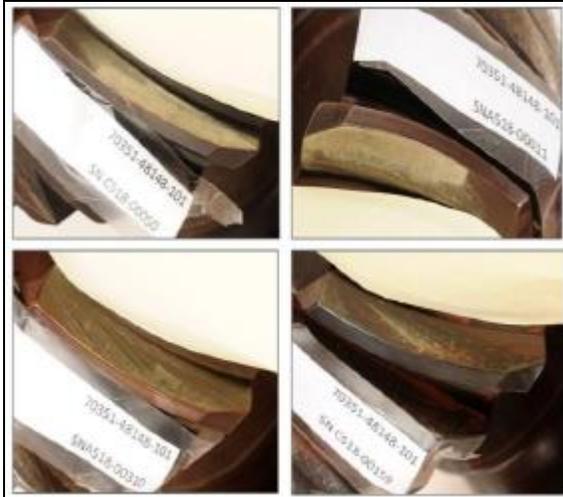
Figure 5. Driving Tooth Surfaces of Candidate Pinions

Four candidate TTO bevel pinions were provided by the SAFR program office for evaluation. Each of these four gears (Figure 4) had varying degrees of surface damage and wear. Photographs of the driving side of a select tooth from each gear are shown in Figure 5.

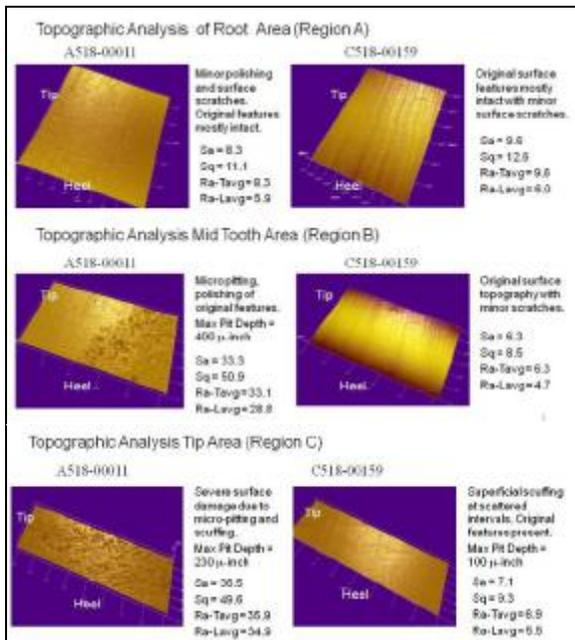
Figure 8. As Received Surface Finish and Topography of Candidate TTO Bevel Pinions

The surface of the TTO pinion SN C518-00159 was generally characterized as having minor damage consisting of surface scratches and some scattered superficial scuffing near the tooth tip. The surface of the TTO pinion SN A519-00011 shows severe micropitting and scuffing originating from the mid section of the tooth out to the tip. The depth of damage in this region is 100-200 micro-inches with a maximum pit depth of 400 micro-inches.

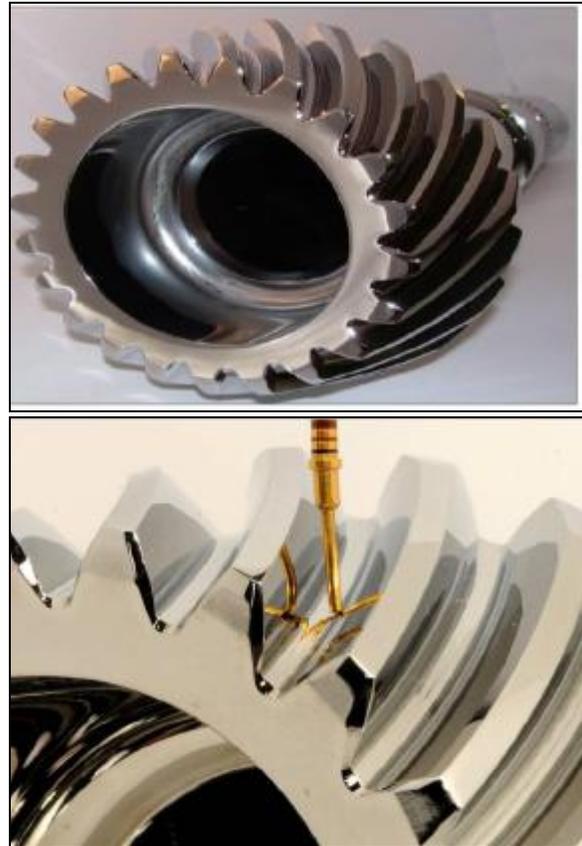
Figure 9. TTO Bevel Pinion Post MMP Treatment

polished surface with a high degree of reflectivity as can be seen in Figure 9. The effect appears to be uniform with the root and fillet areas having the same appearance as the tooth faces and top lands. To the casual observer, the part may appear to have been chrome plated post MMP.

Upon completion of the surface characterization, both pinions were delivered to MicroTek's facility in Hamilton, Ohio to undergo of the MMP surface treatment. The MMP process produces a very highly

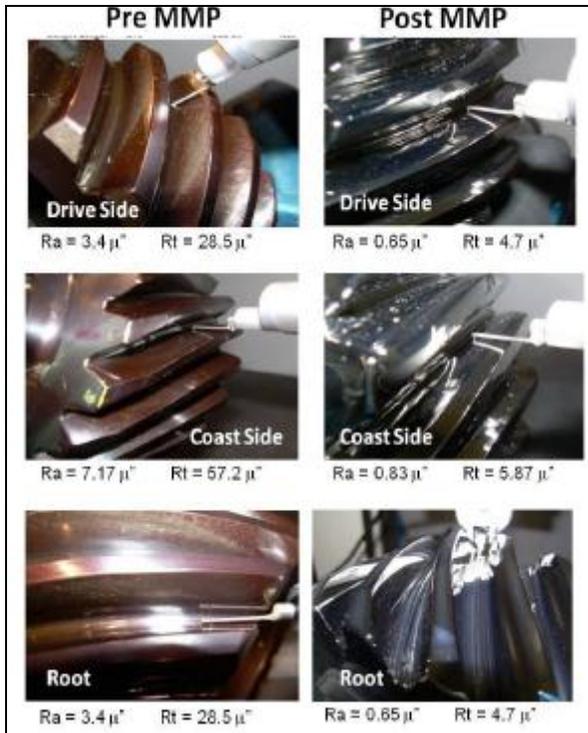
Figure 10. Pre and Post MMP Surface Roughness of TTO Bevel Pinion C518-00159

The pre and post MMP surface roughness of both candidate TTO bevel pinions was measured by MicroTek using a stylus based surface profilometer. Figure 10 shows the results for the TTO bevel pinion C518-00159. The values shown are an average of six individual measurements. It should also be noted that the drive and coast side measurements are in the transverse direction relative to any original finishing (grinding) features which tend to be longitudinally oriented (heel to toe) in nature. The longitudinal grinding features can be seen in the surface topography of the as-received C518-00159 in Figure 8. The root measurements were taken longitudinally or parallel to the lay of the grinding features.

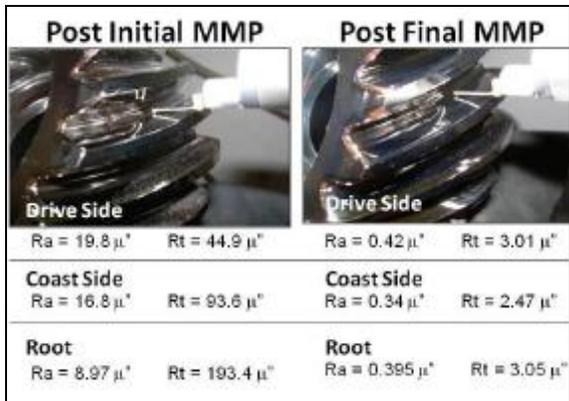
Figure 11. Pre and Post MMP Surface Roughness of TTO Bevel Pinion A518-00011

The TTO bevel pinion A518-00011 proved to be more challenging for the MMP treatment as the surface damage was much more pronounced. Because this was the first time that MicroTek had attempted to reclaim a part of this particular material and geometry, the MMP method was conducted in two stages. The initial processing was deliberately light to assess the material removal rate versus time. Figure 11 shows the results obtained after the initial and final processing. The remnants of the original

pitting damage (shown in Figure 7) can clearly be seen on the tooth surface after the initial MMP treatment. The second (final) treatment essentially removed evidence of the damage, providing a very smooth surface finish.

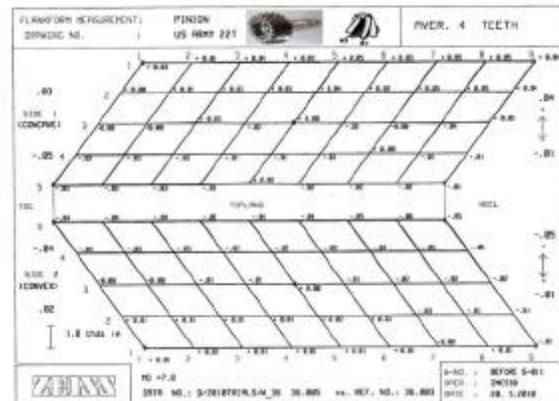
Figure 12. TTO Bevel Pinion A518-00011 Flank Form Analysis After Initial MMP Treatment

Figure 12 shows the effect of the initial MMP treatment on the tooth topography of bevel pinion A518-00011. As expected, the changes were minimal with a maximum of 0.00009 inches being removed from the top land on the concave (driving) side of the tooth. It should

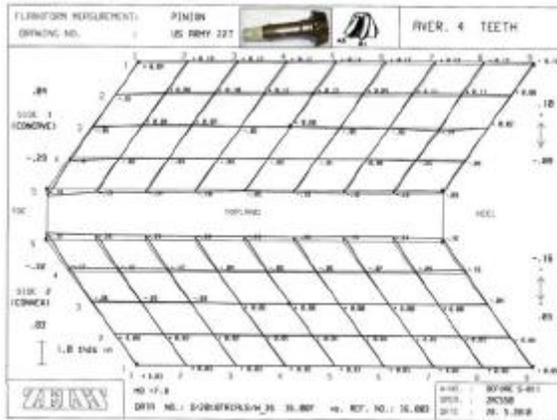
Figure 13. TTO Bevel Pinion A518-00011 Flank Form Analysis After Final MMP Treatment

be noted that Gleason's analysis selects a center point on the tooth as a zero point. The positive values indicated in the root must be added to the negative values shown on the tip to arrive at the total amount of material removed. Figure 13 shows the results of the topographical inspection performed after the second MMP treatment of A518-00011. The

material removal is significantly greater than that achieved in the initial processing. The distribution of material removal is generally uniform from the root

up to approximately 75% of the tooth height and also from heel to toe. In the tip region of the tooth, more material was removed with a maximum reduction of 0.00039 inches on the toe end of the concave (driving) side and 0.00019 inches on the tip of the heel. Observation of the convex (coast) side of the tooth shows a very similar pattern with nearly equal material removal characteristics and the same toe bias. The amount of material removal is consistent with the depth of damage identified during the initial tooth replication and surface analysis as shown in Figure 6. Based upon the Gleason analysis, the change in tooth thickness was determined to be minimal and on the order of 0.0001 inches.

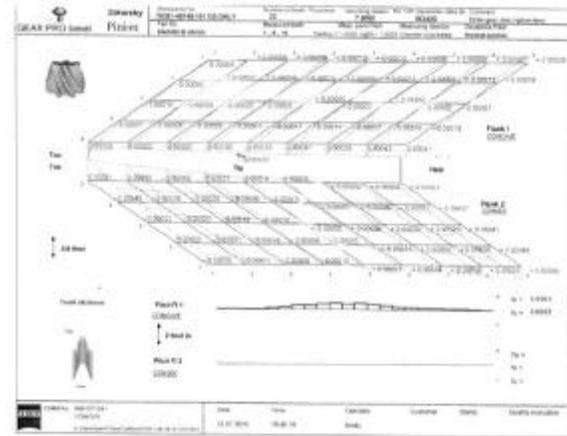
Figure 14. Flank Form Analysis of TTO Bevel Pinion C518-00159 After MMP Treatment

The results of the Sikorsky topological measurements of pinion C518-00159 are shown in Figure 14. The measurements shown are the total deviations from the digital master gear geometry. The maximum deviation on the concave (drive) side of the tooth is -0.00041 inches on the tip of the heel. This is within the 0.0005 inches tolerance allowed by Sikorsky for the drive side of primary power gears of this class and size. While the concave (coast) side of the tooth has significantly more deviation from the master gear, it too is well within tolerance as the requirements for the cost side are double (0.001 inches) that of the drive side. Measurement of the tooth thickness revealed that the change was very small and the pinion would provide a backlash of

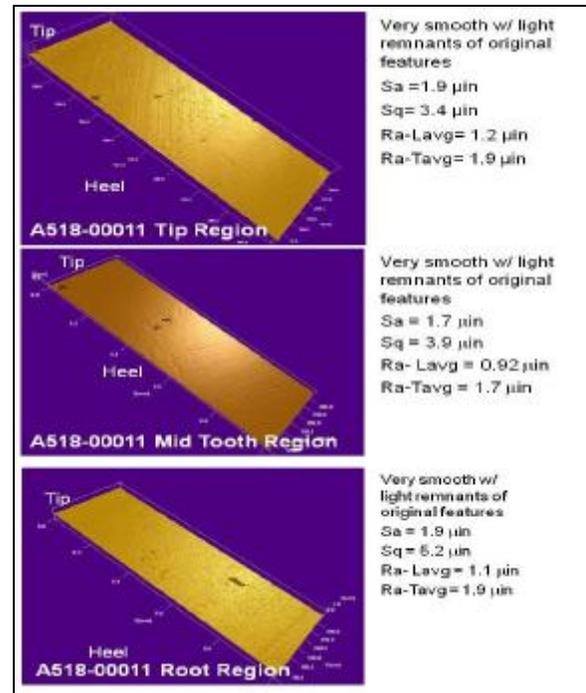
Figure 15. Pinion A518-00011 Post MMP Surface Finish and Topography Characteristics

The surfaces of the gear teeth have a significantly improved finish and exhibit a nearly isotropic texture with only faint remnants of the original wear and machining features. It should be noted that pinion A518-00011 has several randomly distributed pits in each of the three regions. The depth of these pits is approximately 10-20 micro inches (0.23- 0.45 microns) and is probably a remnant from the original surface damage as received (see Figures 7 and 8). Additional MMP treatment may have been able to reduce further the number of these pits. This type of investigation was not possible during this effort due to the small quantity of available assets and associated risk of removing too much material and driving the gear physical geometry past the allowable minimums for tooth thickness and deviation from the desired tooth topography.

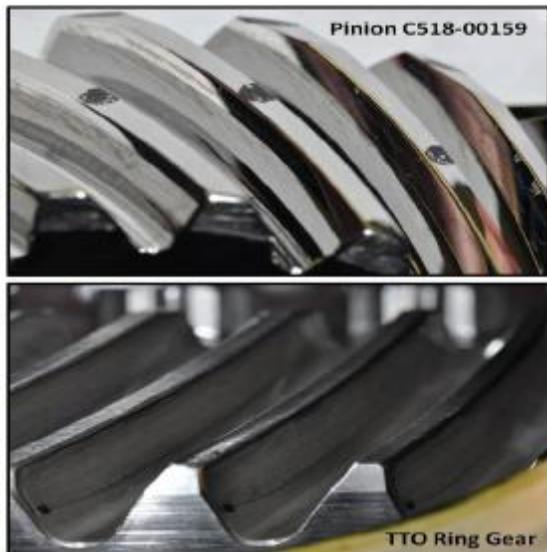
Figure 19. Post Test TTO Pinion and Bevel Gear Gear Tooth Finish and Topography Changes During Testing

TGB were loaded through a single-disk waterbrake dynamometer manufactured by The Kahn Company. The test gearboxes as installed in the HeDS facility are shown in figure 18. Testing was completed in September 2010. Approximately 32 hrs of total operation was accomplished with 16 hrs accumulated at 800 hp, 1 hr accumulated at powers exceeding 900 hp, and 47 minutes at powers slightly exceeding 1050 hp. It should be noted that the TTO gear mesh is currently qualified for maximum continuous operation at 524 hp. Figure 19 shows the posttest condition of the TTO pinion and mating bevel gear.

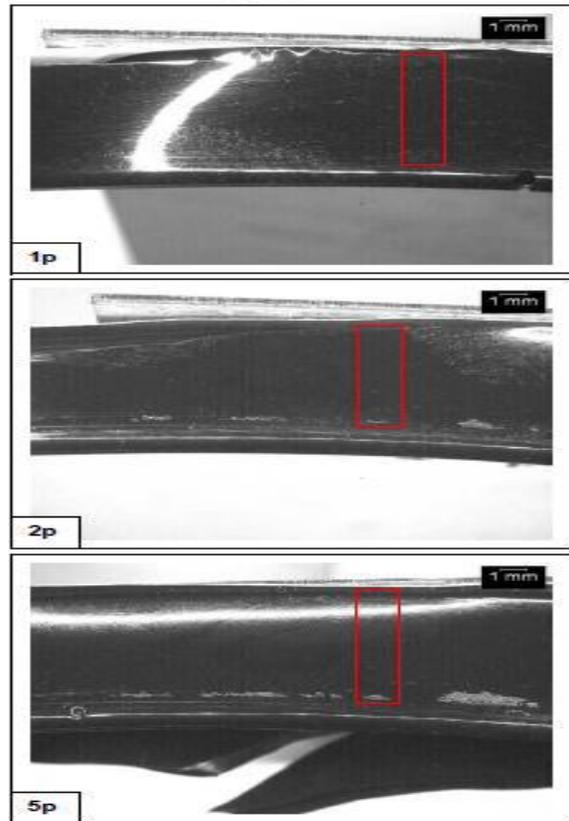
Figure 20. Replicas of TTO Pinion C518-00159 taken at 2 hrs (1p), 12.5 hrs (2p), and 33.5 hrs (5p) of test time

can clearly be seen in replica 2p which was taken at 12.5 hrs of running. This area corresponds to the root area of the actual pinion and is likely the result of an area of high contact stress due to the lack of adequate tip relief at the very high overload conditions applied during the testing. The growth of the line of these pits along the root of the pinion face can be clearly seen in replica 5p which was taken at the conclusion of the testing. A replica taken of the mating gear at the conclusion of the testing is shown in Figure 21. There are no indications of damage to the gear. The directionality of the surface topography of the gear, which was a new production part without the MMP treatment, can clearly be seen in the replica. The directionality of the surface is a direct result of the original grinding process.

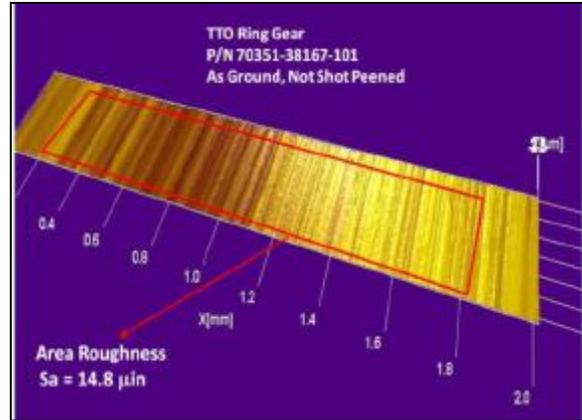
Figure 25. Surface Roughness and Topography of TTO Gear Prior to Testing

gear prior to testing. The surface finish was measured as 15 micro inches (Sa). It should be noted that the TTO gear is not shot peened. Measurements of a production intermediate gearbox spiral bevel pinion, which is ground and shotpeened (Figure 26) show a surface roughness of 12 micro inches (Sa). While the measured Sa values are similar, the texture of the two surfaces is clearly different with the shot peened surface having less directionality as the peaks of the grinding features are reduced. As the endurance testing progressed, a dark line developed on the root area of the TTO bevel gear (see Figure 19). The replica analysis failed to show indications of any change in topography associated with this feature which may be an oil stain. The effect of additional running at 800 hp and the higher transient loads appeared to have little further influence upon the TTO gear surface finish and topography with only a slight changes in surface finish as shown in Figures 27 and 28.
